Manhole Inspection Summary

Manhole # S51U1_001MH

Insp Date: **5/30/08 1:34 PM**

Location Address: **3101 Vera St.**

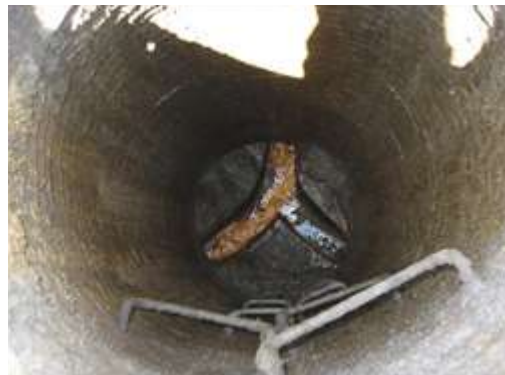
Top View

Frame Offset: **3** (in.) Condition: ☐ Sound ☒ **Cracked** ☐ Leaks

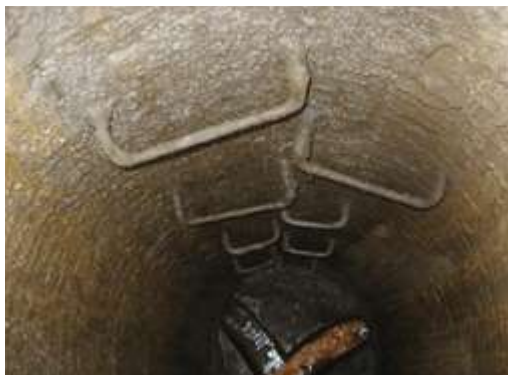
Steps Count: **8** Missing: **0** ☐ Corroded

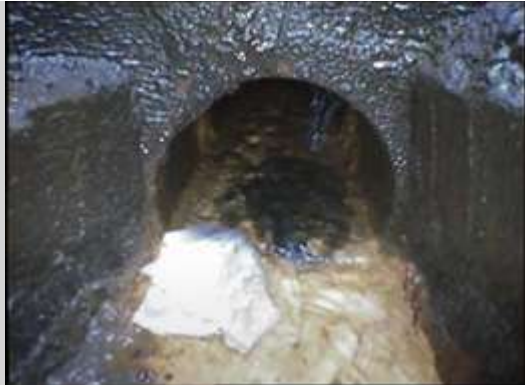
12 O'Clock Outflow

8 in. Circular Gravity Sewer
Pipe Out @ 12 O'Clock

Pipe Height: **9.6** (in.) Rod and Bar (Angled)
Pipe Material: **Clay** ☐ Pipe Lined
Invert Depth: **12.20** (ft.) Flow Characteristics: **Slow**
Deposits: ☒ None ☐ Mud ☐ Sludge ☐ Debris ☐ Grease
Silt Depth: (in.) Deposits Extent:
Infiltration: **None** Pipe Seal Cond: **Sound**

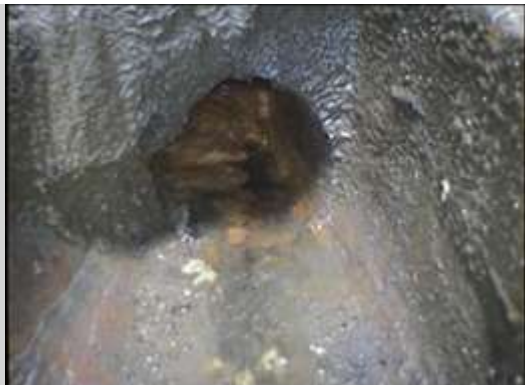
5 O'Clock Inflow

8 in. Circular Gravity Sewer
Pipe In @ 5 O'Clock

Pipe Height: **13.2** (in.) Rod and Bar (Angled)
Pipe Material: **Clay** ☐ Pipe Lined
Invert Depth: **11.90** (ft.) Flow Characteristics: **Slow**
Deposits: ☒ None ☐ Mud ☐ Sludge ☐ Debris ☐ Grease
Silt Depth: (in.) Deposits Extent:
Infiltration: **None** Pipe Seal Cond: **Sound**

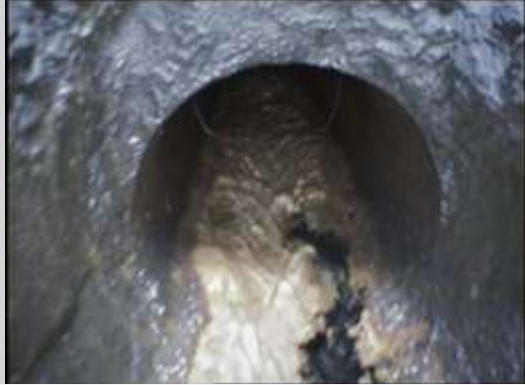
7 O'Clock Inflow

Pipe Height: **8.4** (in.) Rod and Bar (Angled)

Infiltration: **None** Pipe Seal Cond: **Sound**
